**SAFEVENT**  
 Mads Clausens Vej 6  
 9800 Hjoerring  
 Denmark

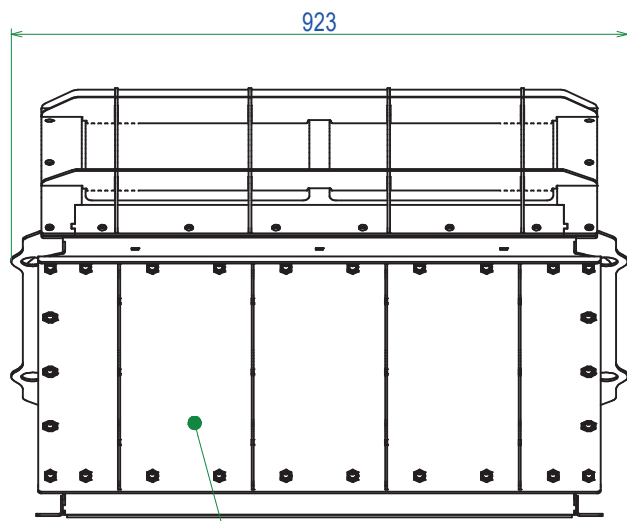
Inspection door

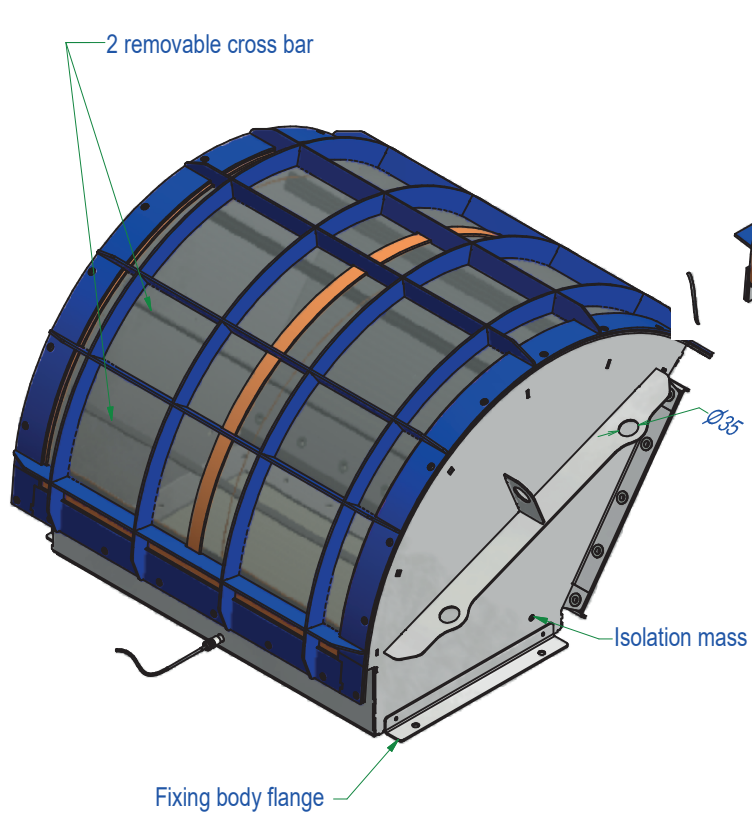
2 removable cross bar

Isolation mass

Fixing body flange
